"CASH SPECIAL"

"SHORT
CASH SPECIAL"
STUNNERS

MAINTENANCE and REPAIR
MANUAL

ACCLES & SHELVOKE LTD

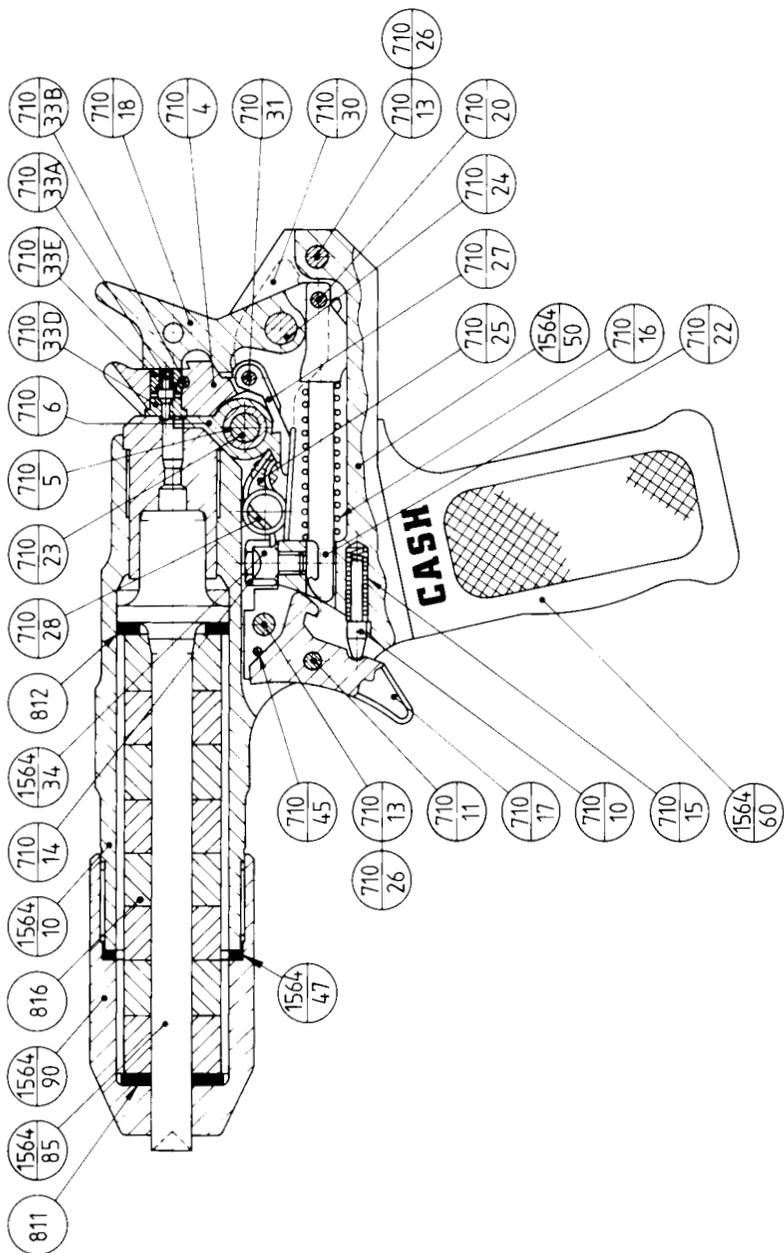
THE "CASH SPECIAL" CAPTIVE BOLT STUNNER

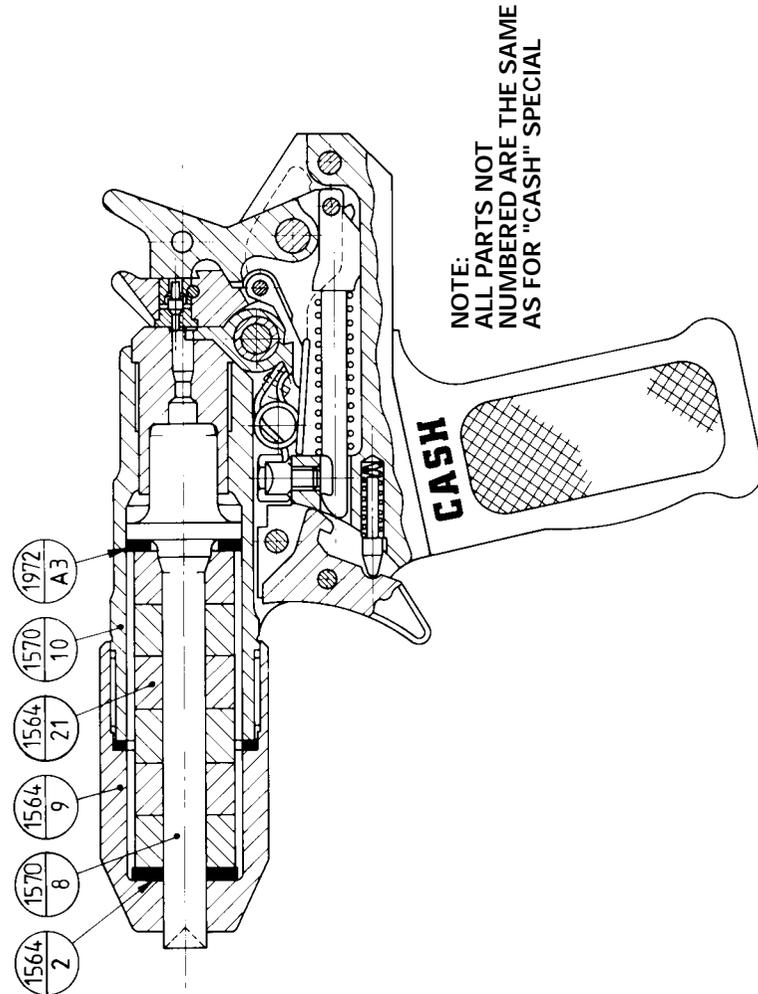
THE "SHORT CASH SPECIAL" CAPTIVE BOLT STUNNER

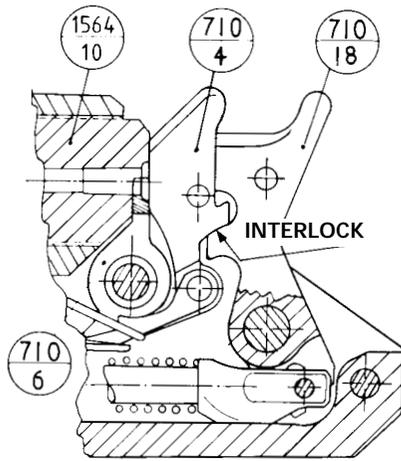
FIG. 5

FITTING PROCEDURE (Fig. 5)

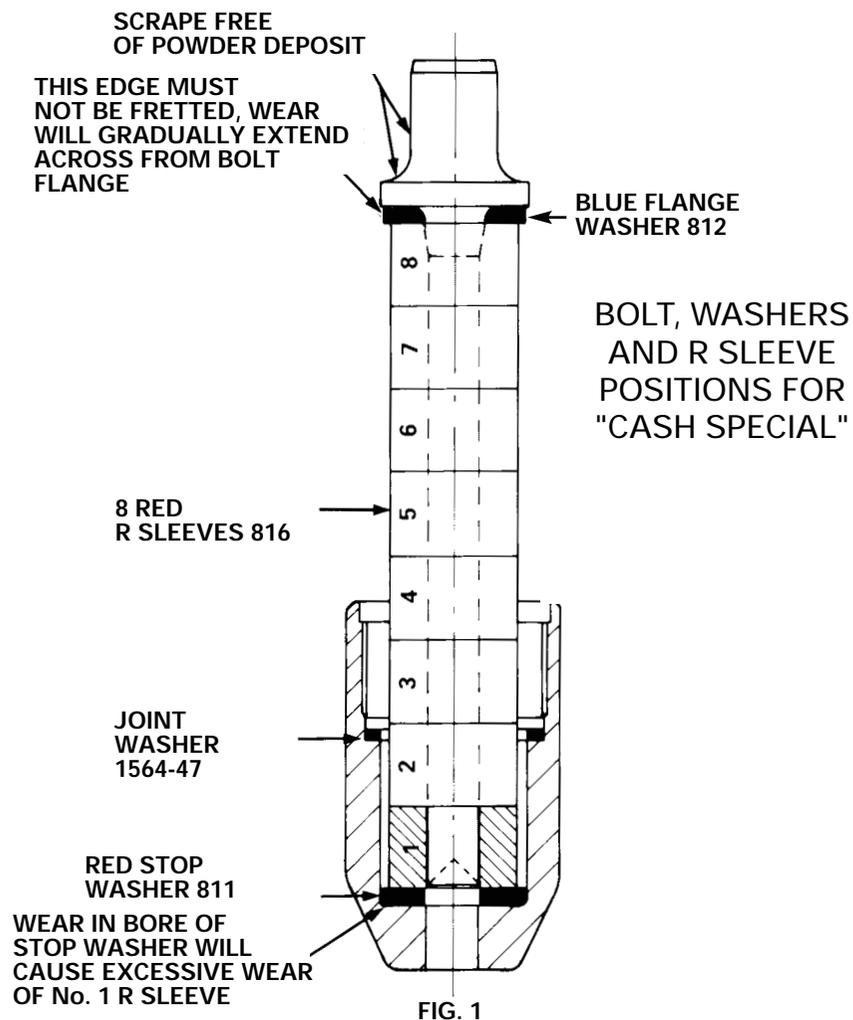
FIG. 1

NOTE: After a few shots with a new set of sleeves they will settle and shorten in length. Expect therefore that with a new set of 8 sleeves the muzzle may be difficult to reassemble to barrel as the sleeves will have to be compressed to engage threads.

NOTE: Providing stop washer is in good condition, the sleeves in position 1, 2 and 3 are less stressed than other positions. To even wear change position of sleeves so that the sleeves which are most worn are in these 1, 2 and 3 positions. If sleeves 4, 5, 6, 7 and 8 are wearing prematurely check that joint washer is in good condition and that the muzzle cap is screwed down to seat on this washer, wear to the outside or the bore of sleeve No. 8 can be caused, by a worn flange washer.

8. When re-assembling it is ESSENTIAL that Flange Washer, Recuperator Sleeves and Stop Washer are assembled in their correct positions, exactly as in Fig. 1 OR Fig. 2 for 'Short' model.
Note: The Stop Washer will probably remain firmly in the Muzzle Cap. This is in order.

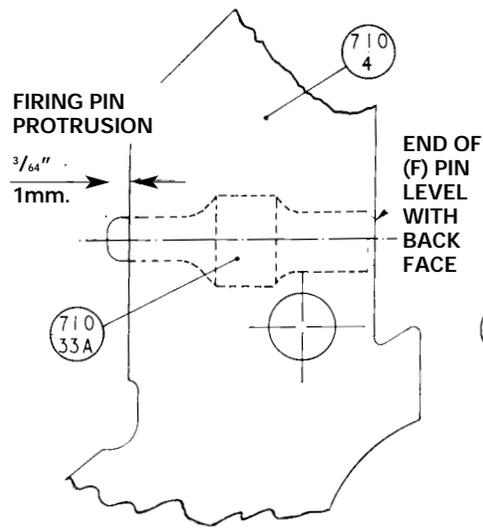
FIG. 3

To fit new Firing Pin, Part No. 710/33A - see Figs. 3 and 4

1. Hold Firing Block (710/4) vertically in smooth-jawed vice.
2. With suitable ($3/32$ " dia.) hand pin punch, drive out the Back Bush Rivet (710/33B) driving from the countersunk end of hole.
3. Replace Firing Block (710/4) horizontally in vice with Firing Pin point uppermost i.e. Pawl (710/27) is underneath. With a small diameter hand pin punch inserted in the Firing Pin Hole drive out the broken Firing Pin (710/33A) and Back Bush (710/33E).
4. Remove Firing Block from vice and examine Firing Pin seating for damage or burrs and remove these if necessary.
5. Insert new Firing Pin (710/33A) and push it in as far as it will go. It should fit snugly on its seating.
6. Hold in position and check that the protrusion of the domed point of Firing Pin (710/33A) is $3/64$ " (1 mm).

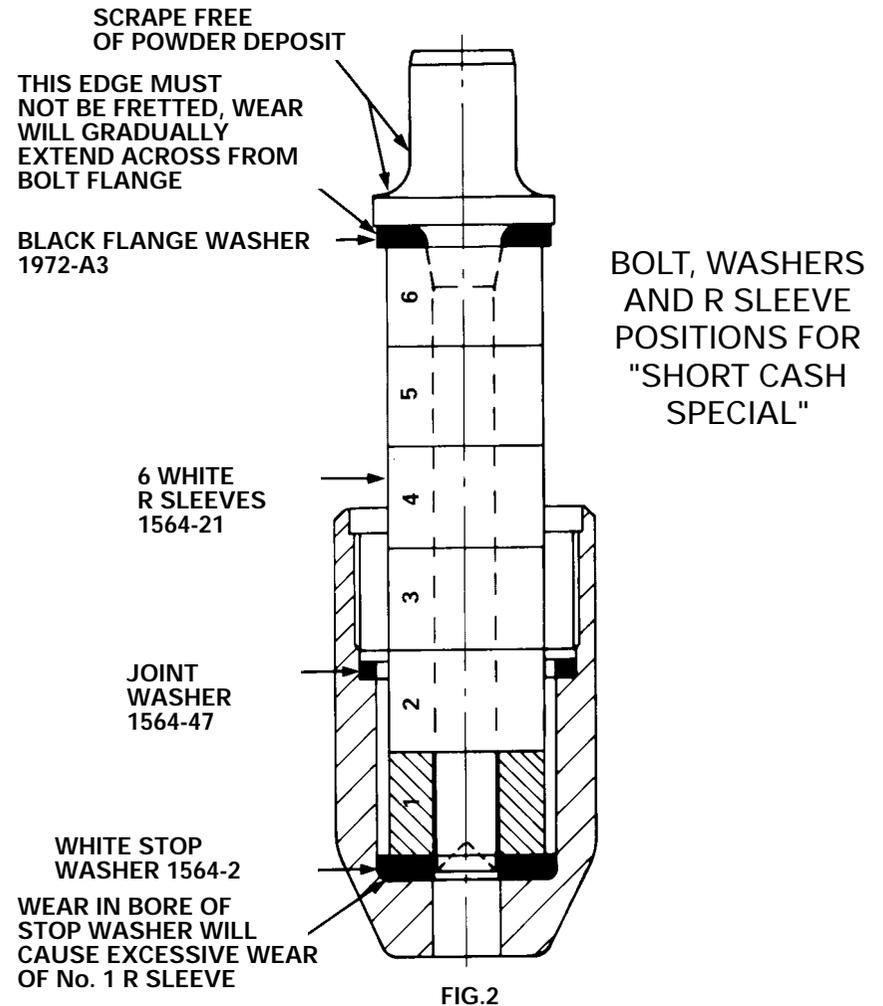
FIG. 2

NOTE: After a few shots with a new set of sleeves they will settle and shorten in length. Expect therefore that with a new set of 6 sleeves the muzzle may be difficult to reassemble to barrel as the sleeves will have to be compressed to engage threads.
